# INTERNATIONAL CONFERENCE PERUĆA DAM REMEDIATION

*January 28, 1993*

**PERUĆA DAM REMEDIATION**

**PROCEEDINGS**

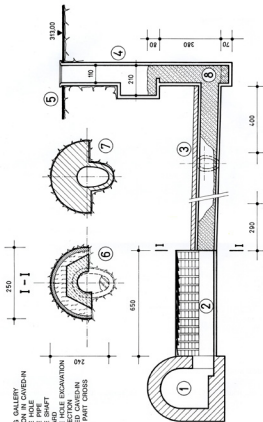
Figure 8. Remediated drainage pipe

1. GROUTING GALLERY
2. EXCAVATION IN CAVED-IN DRAINAGE HOLE
3. DRAINAGE PIPE
4. DRAINAGE SHAFT
5. SWITCHYARD
6. DRAINAGE HOLE EXCAVATION CROSS SECTION
7. REMEDIATED CAVED-IN GALLERY PART CROSS SECTION

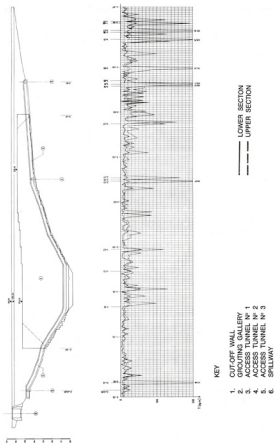
Figure 4. Grout curtain remediation under the dam

The **lower stage** boreholes length is 1,100 m, the cement and bentonite consumption 26,559 kg, thus the average dry matter consumption was 24.14 kg per meter of grouted lower stage. The plot 1 in Fig. 3 leads to the conclusion that the average consumption is comparatively low and uniform, which confirms the impermeability test results which indicated that the curtain was not damaged in explosion.
