# INTERNATIONAL CONFERENCE PERUĆA DAM REMEDIATION

*January 28, 1993*

**PERUĆA DAM REMEDIATION**

**PROCEEDINGS**

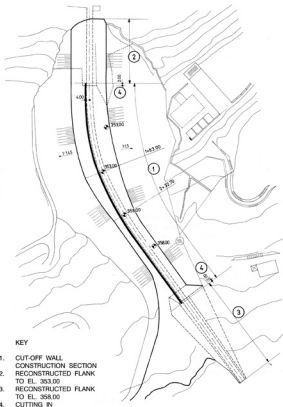
Figure 1. Dam layout with cut-off wall

The Peruća Dam remediation project included construction of a plastic concrete cut-off wall within the central dam section. The cut-off wall was intended to take over the function of an impermeable dam element instead of the damaged clay core. The cut-off wall was constructed between the stations 0+87.70 and 3+44.00, along the dam axis.

The joint between the reconstructed dam sections in the left and right end and the section which includes the cut-off wall as an impermeable element is designed so that the cut-off wall is min. 2 m long structure incorporated in the clay core of the reconstructed sections.

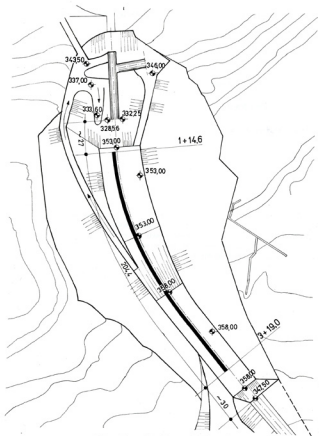
Figure 1. Grouting curtain layout

The dam core grouting with cement-bentonite slurry was aimed at decrease in the slurry loss risk and increase in trench shear resistivity during construction of the cut-off wall, as described in the paper titled "Dam Core Grouting".

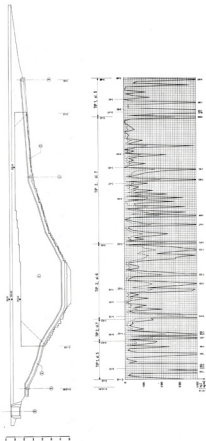
The consumption in different profiles is not uniform, and it shows a trend of higher frequency of the below-average consumption. The conclusion is derived from the coefficients of variation and the skewness coefficient which are  $c_v = 1.41$  and  $\alpha_3 = 2.02$ , respectively. The maximum consumption in the grouting profile was 16,412 kg in station 3+47, and the minimum of 21 kg in station 3+61.

The reason for such a high consumption is seriously damaged rock, and consequently completely disturbed contact between the concrete lining and the bedrock.

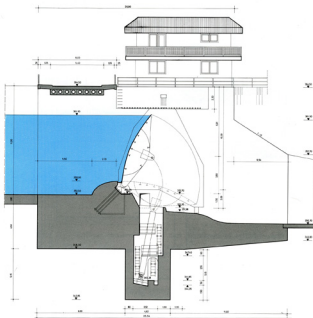
Figure 1. Spillway structure - longitudinal section

The works on removal of the existing concrete structure were intensified in January 1995. The structure demolition and removal was carried with drilling rods, blasting, cutting the reinforcement bars and embedded steel members, and removal from the site to the spoil area. When the steel structure was removed, the excavation in bedrock started for the flap hydraulic cylinder shaft and spillway slab.

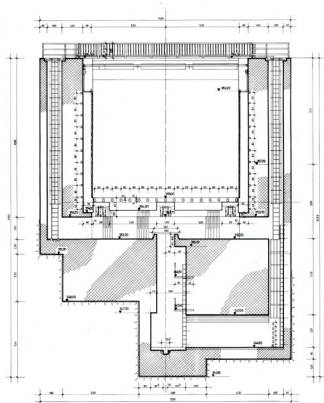
*Figure 2. Spillway structure cross-section through the hydraulic cylinder shaft and air vents*

In April 1995, the excavation was followed by concreting of the cylinder shaft and spillway concrete structure, Photo 2. The spillway concrete was MB-30, with ribbed reinforcement RA 400/500. The spillway concrete placement went on into two stages. In the first stage, the structure with the holes left for installation of the hydromechanical equipment was concreted. During this stage the anchors and anchor plates are embedded to which the equipment shall later be welded. The second stage includes concreting of the holes.
